Explosive Azides

Lawrence Berkeley National Laboratory Lessons Learned

LL-2003-01

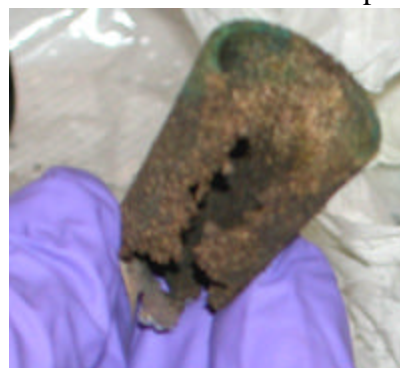
Incident: A chemist was conducting maintenance on a small brass filter, an air drying system component connected to a water container. As the chemist was cleaning the filter with a wire brush a small explosion occurred that resulted in minor blistering of the left thumb and index finger. Because this cleaning operation was being performed in a chemical fume hood, the energy from the explosion was somewhat contained. The employee sought medical treatment at Health Services and returned to work the same day.

Brass filter following explosion

Cause: Sodium azide was added in very low concentrations (~0.05%) to prevent algal growth in the water container of the air-drying unit. A small amount of sodium azide was deposited on the brass filter during normal operation of the unit. The sodium azide reacted with the copper in the filter to form a potentially explosive mixture sensitive to both shock and friction (such as cleaning with a wire brush).

- ❑ Substitute less reactive materials for metal parts when azides and metal parts can form reactive mixtures (in this case, the brass filter was replaced with a PVC tube).
- ❑ When substitution is not feasible, thoroughly wash metal parts before exposing them to sources of potential friction or shock.
- ❑ Consider an alternate material to suppress algal growth.
- ❑ All employees working with azides must be current on EHS0348, Chemical Hygiene & Safety Training, before handling these materials. In addition, reference materials, such as Material Safety Data Sheets or MSDSs, should be reviewed to identify the specific hazards and necessary precautions when working with particular azide compounds.
